**ACOUSTIC SYSTEMS  
ACOUSTICAL RESEARCH FACILITY  
OFFICIAL LABORATORY REPORT  
AS-TL1945**

**Subject: Sound Transmission Loss Test**

7/8" Acoustic Composite

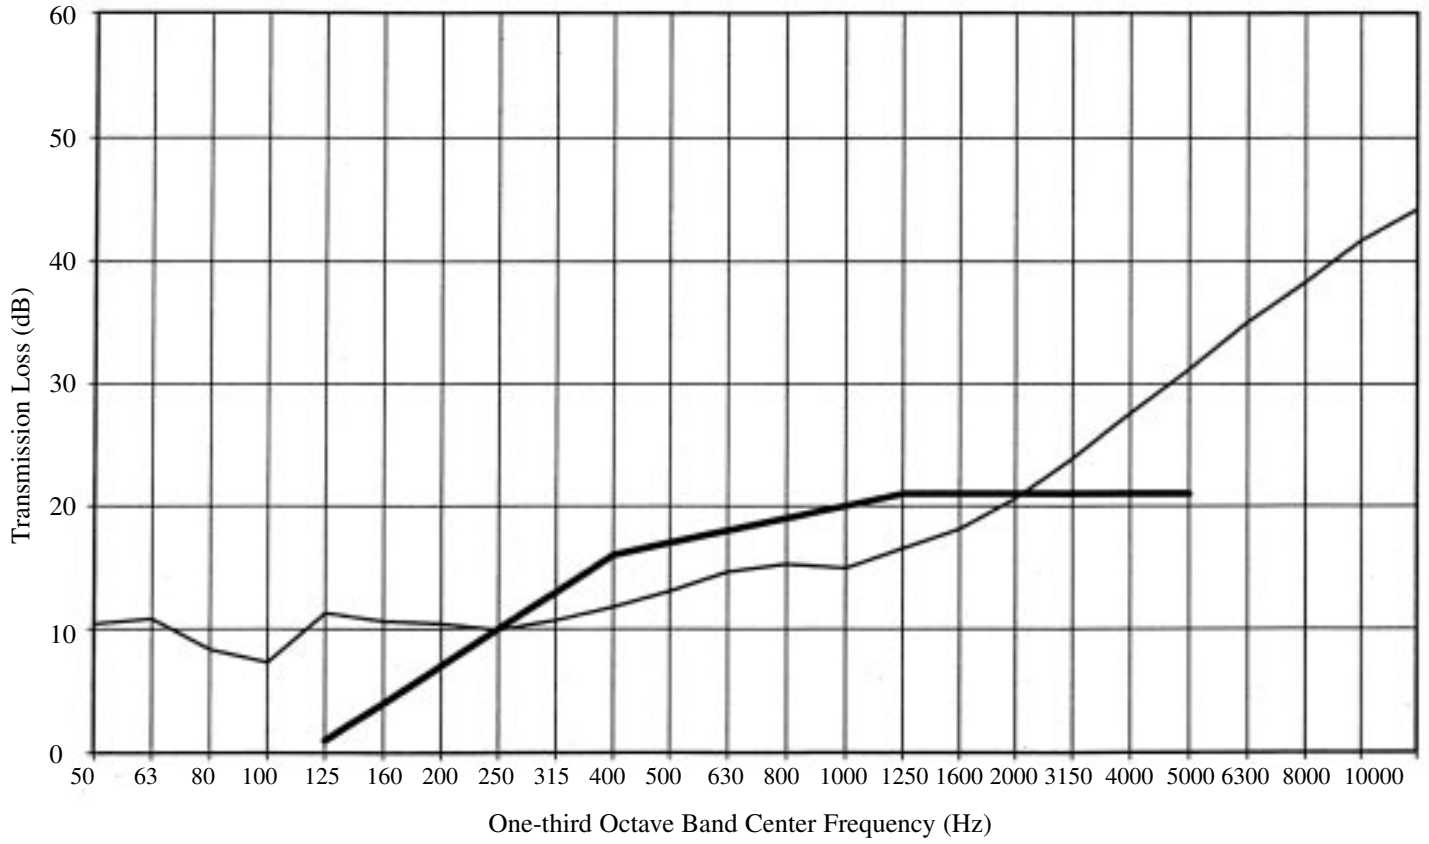
### 7/8" Acoustic Composite AS-TL 1954; STC 17 OITC 14

The Sound Transmission Loss of the test specimen at the preferred one-third octave band center frequencies is tabulated below and then presented graphically. Octave-band Transmission Loss values are calculated as described in Section 12.4 of ASTM E90-99.

1/3 Octave Band Center Freq. (Hz)	Transmission Loss (dB)	Uncertainty (+/-dB)	NOTES	Octave Band TL (dB)	STC Deficiencies
50	10		[g]		
63	11		[g]	10	
80	8	2.4	[g]		
100	7	2.0			
125	11	2.6		9	
160	11	1.6			
200	10	0.7			
250	10	0.9		10	
315	11	0.7			2
400	12	0.6			4
500	13	0.5		13	4
630	15	0.5			3
800	15	0.4			4
1000	15	0.4		16	5
1250	17	0.3			4
1600	18	0.2			3
2000	21	0.3		20	
2500	24	0.3			
3150	28	0.2			
4000	31	0.2		30	
5000	35	0.3			
6300	38	0.4			
8000	42	0.5		41	
10000	44	0.8			
<b>STC</b>	<b>17</b>				
<b>OITC</b>	<b>14</b>
